Name of Dam: Ragged Mountain No. 1
Location: Albemarle County, State of Virginia
Inventory Number: VA 00304

PHASE I INSPECTION REPORT NATIONAL DAM SAFETY PROGRAM

PREPARED BY
MICHAEL BAKER, JR., INC.
BEAVER, PENNSYLVANIA 15009

Name of Dam: Ragged Mountain No. 1
State: Virginia
County: Albemarle
Stream: Moores Creek
Date of Inspection: 26 July 1978

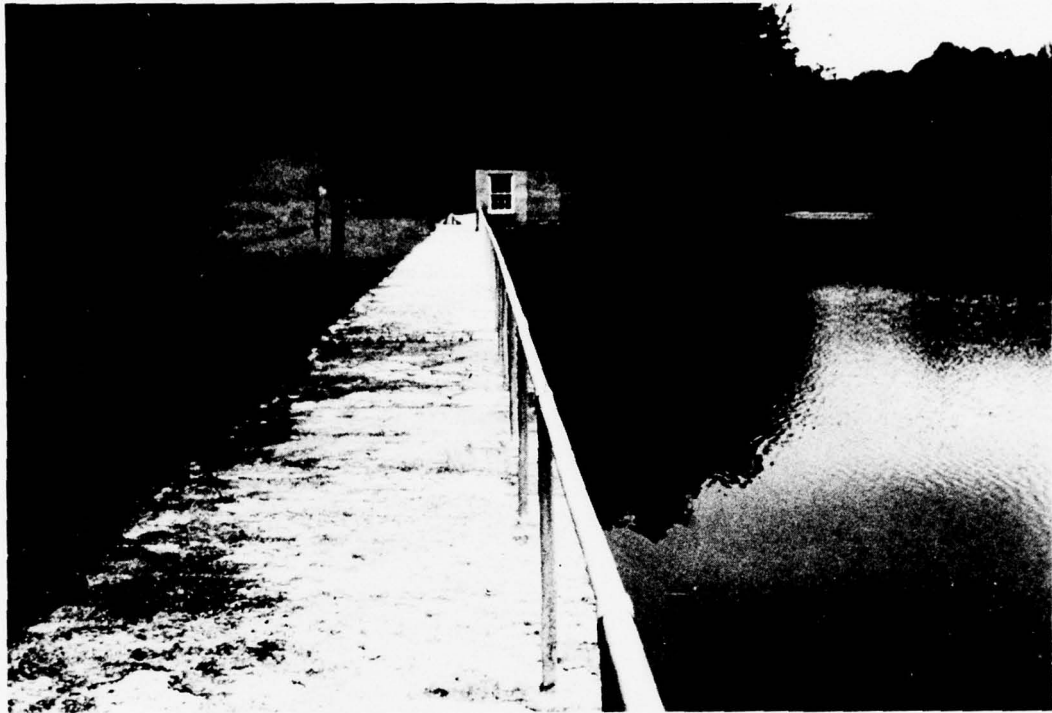
- 1.2.1 Description of Dam and Appurtenances: Ragged Mountain Dam No. 1 is an apparent combination concrete gravity and earthfill dam approximately 67 feet high and 400 feet long. The crest width is 24 feet with a 7.5 feet wide concrete walkway adjacent to the reservoir. The embankment has been constructed with two horizontal to one vertical (2:1) over 1.5:1 downstream slope ratios. A vertical concrete wall forms the upstream face of the dam which extends from crest level into the reservoir for an undetermined depth (see Photo 1).

PHOTO 1. View of Dam Crest, Gate House and Reservoir From Left Abutment

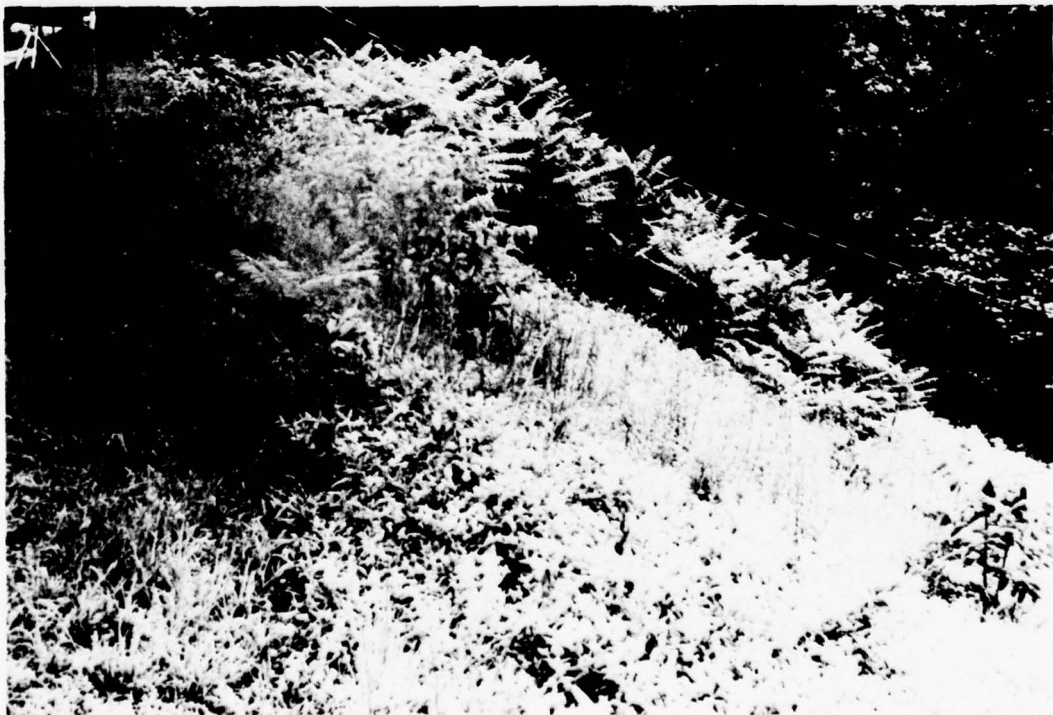
PHOTO 2. View of Downstream Face of Dam From Right Abutment Area

The large trees and debris should be removed from the downstream face of the dam especially in the area of the gutters.

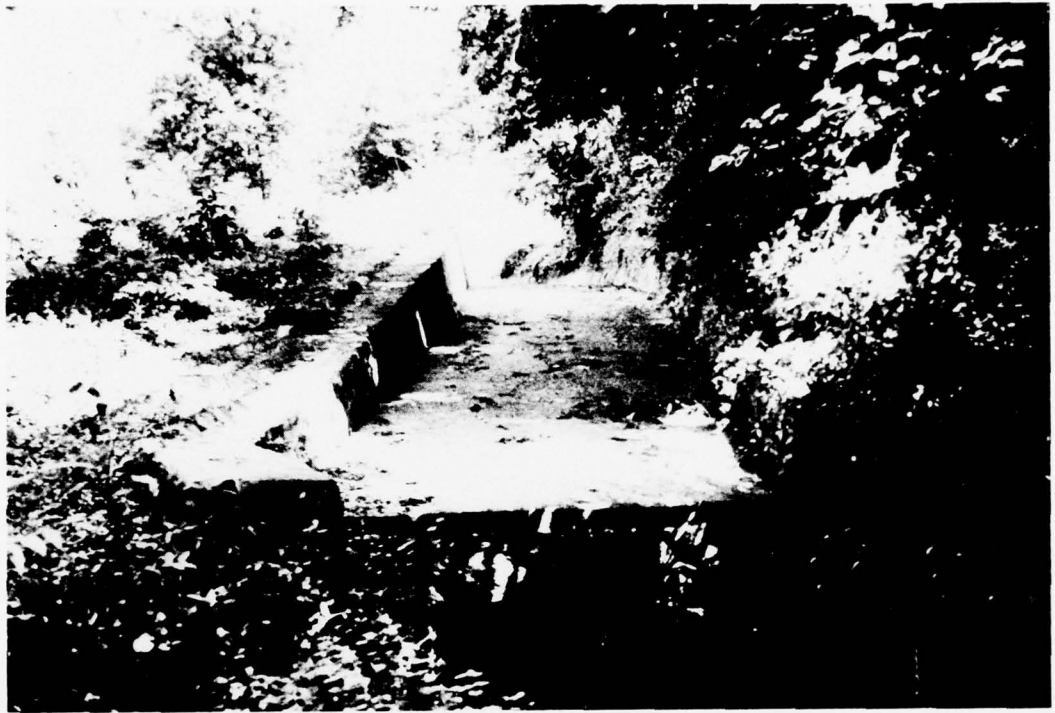
PHOTO 3. View of Emergency Spillway Looking Upstream

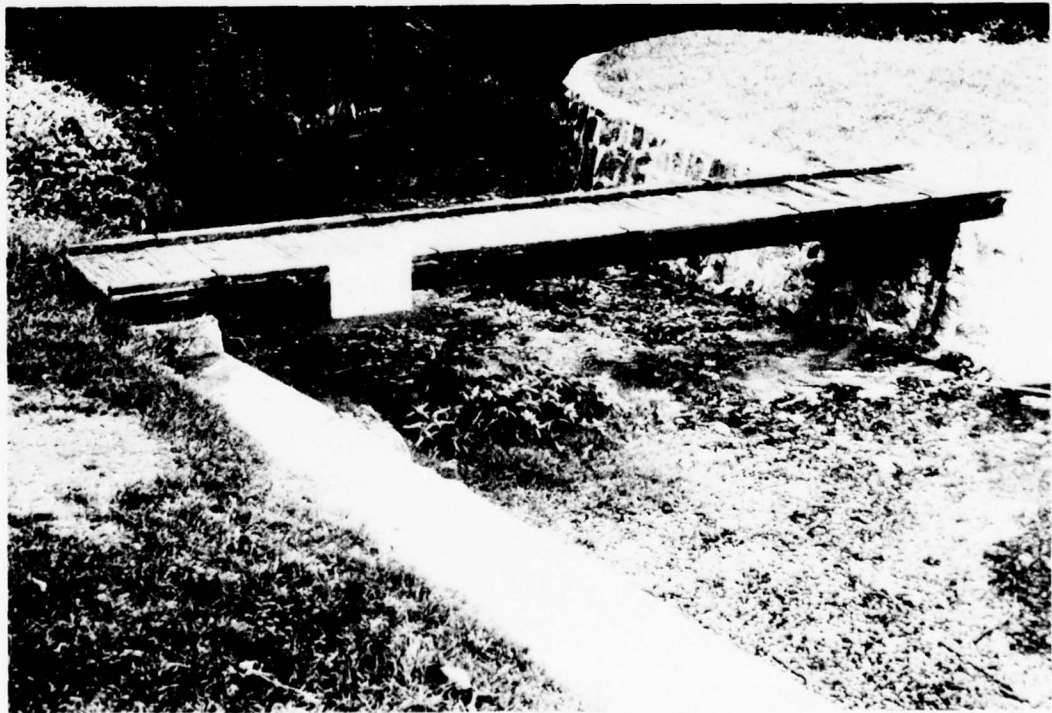
PHOTO 4. View of Emergency Spillway Looking Downstream

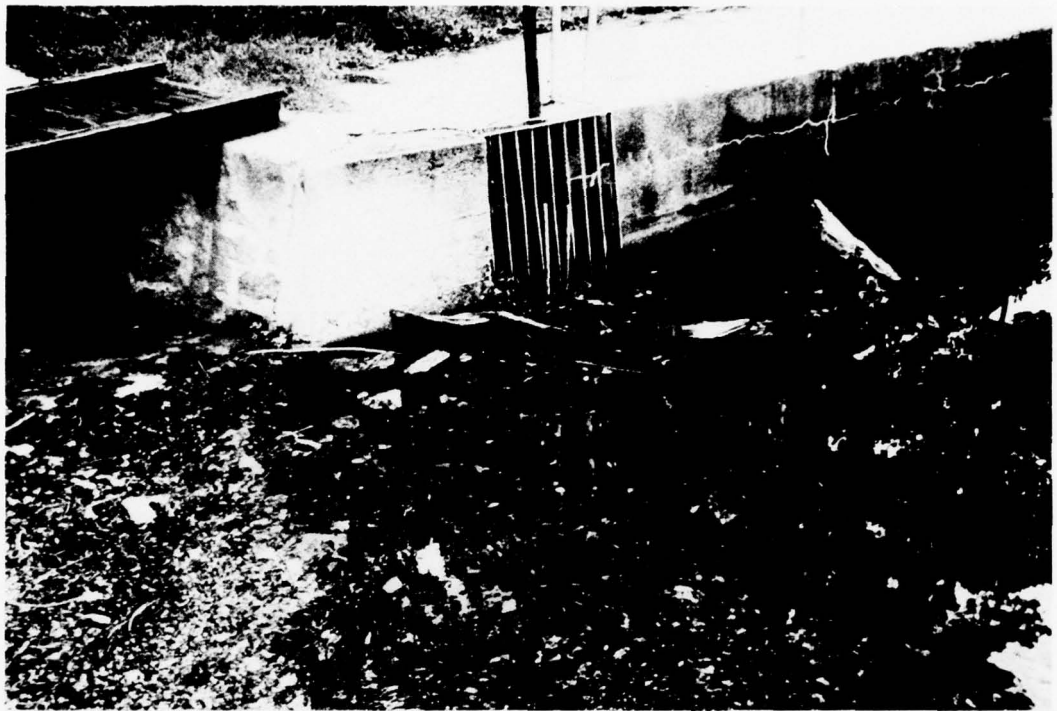
A 30 inch diameter cast-iron pipe keep is located four feet to the right of the open channel spillway. The pipe has two flashboards placed in front of the intake and behind a trash rack (see Photo 5).

PHOTO 5. View of 30 Inch Intake Pipe and Trash Rack Adjacent to Emergency Spillway

3.2.2 Appurtenant Structures: The 30 inch diameter high water pipe adjacent to the spillway needs no repair at this time.

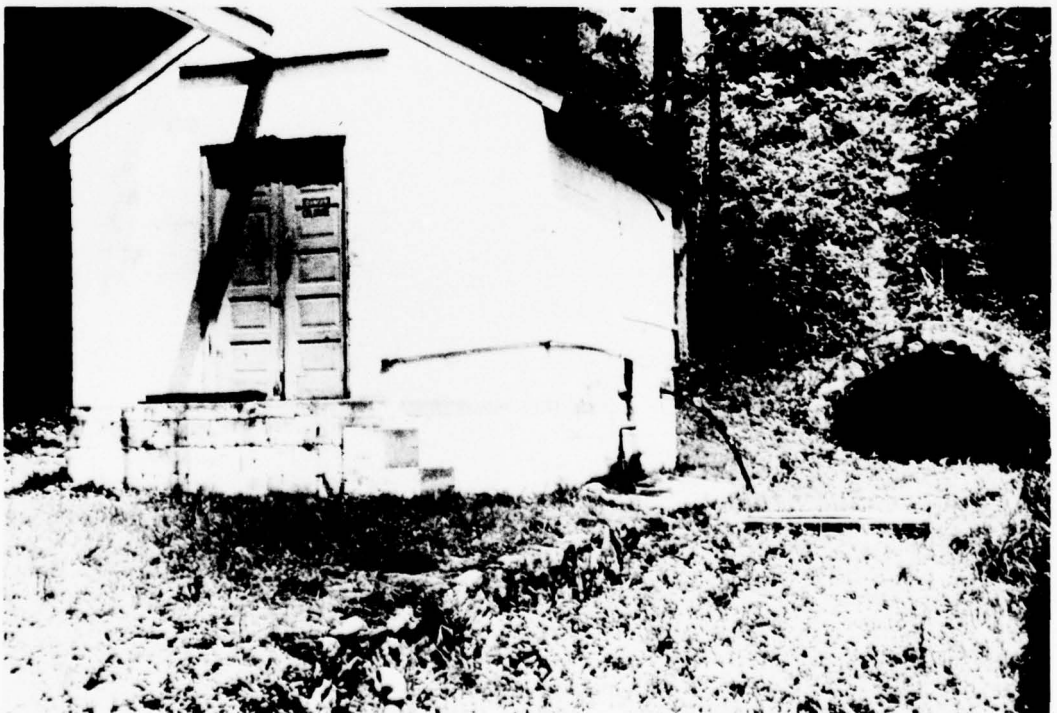
The gate house is located approximately at the midpoint of the dam (see Photos 3 and 4). An 18 inch pipe carries water from the gate house to a small treatment building located at the toe of the dam. There chemicals (presently chlorine for algae control) are added to the water supply main used to supply the City of Charlottesville, Virginia (see Photo 6).

PHOTO 6. View of Chlorinating House and Concrete Arch Culvert at Toe of Dam

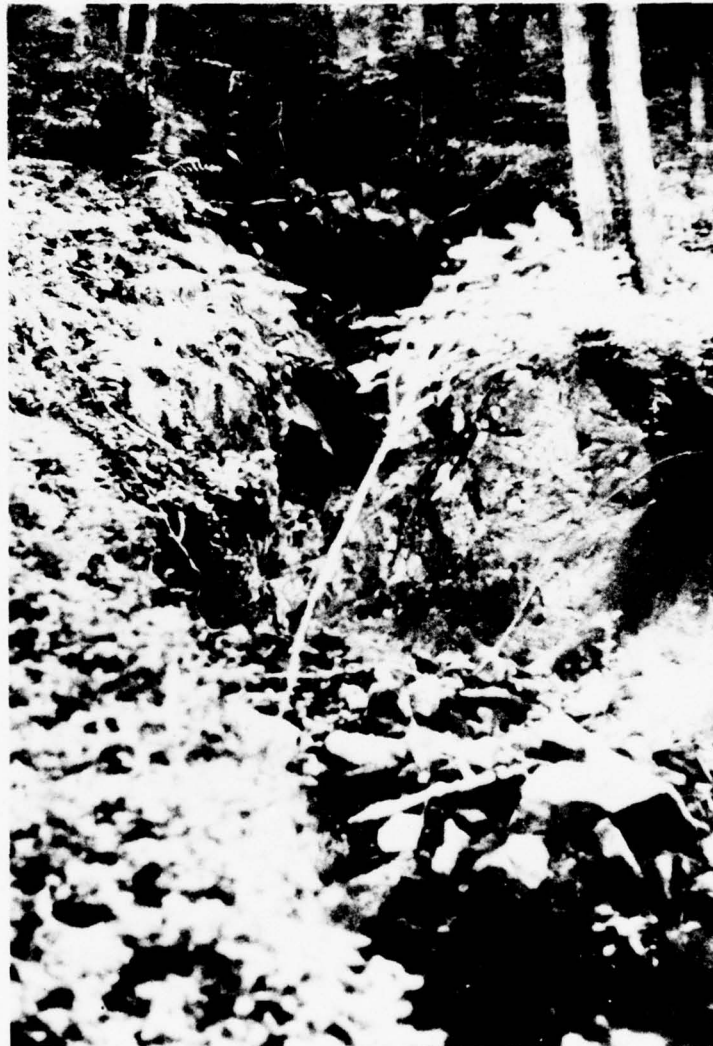
3.1.5 Downstream Channel: The downstream channel below the end of the emergency spillway consists of hard coarse quartz monzonite with steep to vertical joints. The banks of the channel have been undercut by high flows (Photo 7). Boulders, cobbles and weathered bedrock are present throughout the channel. Wooden debris and a tree which has been undercut constrict flow approximately 150 feet downstream from the paved spillway.

PHOTO 7. View of Scoured Downstream Channel

3.2.4 Downstream Channel: Placement of heavy riprap in the highly scoured area downstream from the paved spillway should be done immediately to insure against further serious scour

of the stream channel and undermining of the overbanks.
